Investigation of head-neck tapers in modular hip prostheses

Submitted in accordance with the requirements for the degree of Doctor of
Philosophy

School of Engineering and Materials Sciences

September 2017

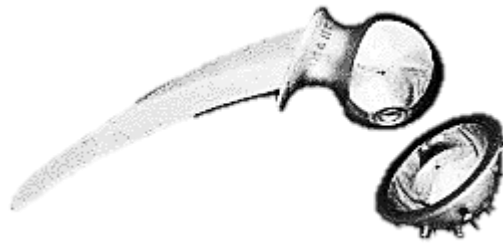
Figure 2-2 Mc-Kee Farrar prosthesis with a monoblock stem

Components of total hip replacement devices may be considered as monoblock or modular. Monoblock components (Figure 2-2) are manufactured as a unit without the possibility of disassembly whilst modular devices can be assembled and disassembled. Thus, any hip replacement may be modular or monoblock; designs have featured modularity within stems, between a head and a stem, within acetabular components and within the femoral head (Figure 2-3). Despite the variations in modularity, the most common type of femoral modularity is currently the head-neck or head-sleeve-neck junction. The head-sleeve-neck junction is essentially a head-neck junction with an adapter sleeve interposed between the head and neck, which is widely utilised at revision.

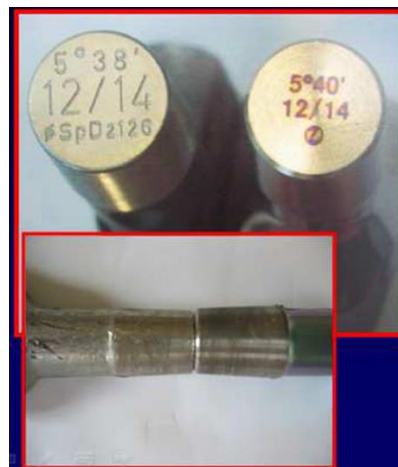
Figure 2-5 Variation in a 12/14 taper (Hernigou et al., 2013)

Taper sizes are specified with respect to the approximate proximal and distal diameters in mm. Hence available sizes include 8/10, 9/11, 10/12, 11/13, 12/14 and 14/16. There are also tapers with proprietary names including the V40, C-taper, Type-I, Type-II and PCA (Table 2-1). Contemporary designs feature smaller proximal and distal diameters as well as shorter lengths to avoid impingement of the prosthetic neck against the acetabular component and improve the range of motion (ROM) possible (Morlock et al., 2011). Hence, trunnion lengths have been reduced from 20 mm to below 10 mm and 12/14 and V40 tapers are more commonly used in place of 14/16 tapers (Morlock, 2015). Although two tapers may have the same proximal and distal diameter, the angle of approach from the bottom to the top diameter can vary (Bisseling et al., 2013) (Figure 2-5). A range of angles exist for Morse tapers used within implants (Hernigou et al., 2013) . The original Morse taper angle was a relatively small angle of 2.833°, but in current joint replacement devices, the taper angles range between 2 and 18° (Hernigou et al., 2013, Tan et al., 2015).

Taper design	Proximal diameter (mm)	Distal diameter (mm)
11/13	11.2±0.1	13.5±0.1
12/14	12.5±0.7	13.7±0.7
C-taper	12.4±0.4	13.8±0.7
V40	11.3±0.4	13.3±0.6
Type-I	11.7±0.9	12.7±0.9
PCA	12.3±0.7	13.3±0.5

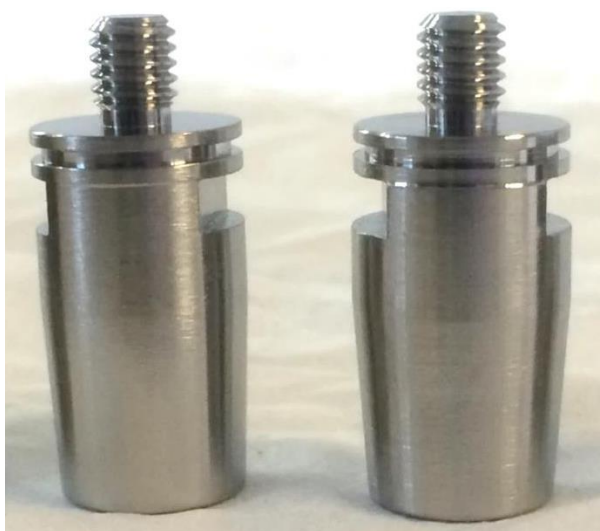
Figure 6-1 A smooth 5° trunnion and a smooth 8° trunnion

Table 6-1 Characteristics of samples evaluated on the hip simulator; Rough: Rz 16 + 3 µm, Smooth: Rz 6 + 3 µm, all heads were CoCr

Sample ID	Features		Contact condition	Femoral head offset
	Angle	Topography		
1ER	5°	Rough	Proximal	+0 mm
2ER				
3ER				
4ER				
5ER		Smooth		
7ES				
8ES				
1DR				
2DR	8°	Rough	Distal	-4 mm
3DR				
4DR				
5DR				
6DR		Smooth		
1DS				
3DS				
4DS				
7DS

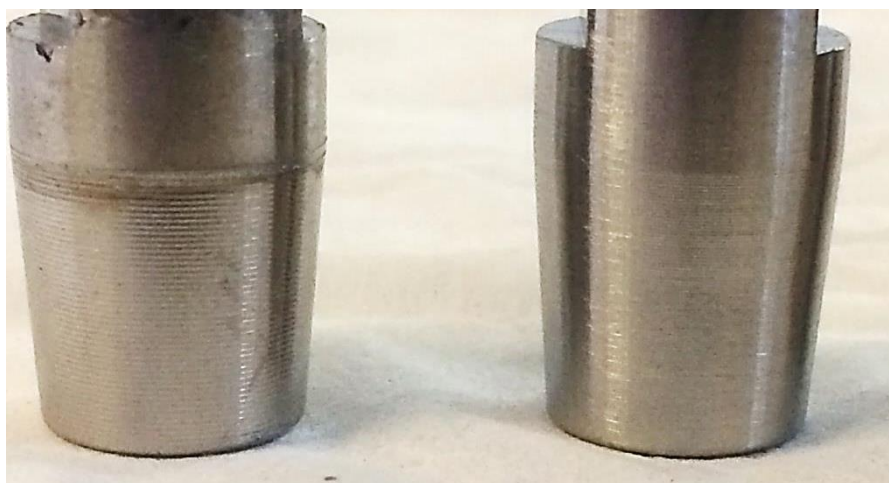
Figure 6-2 A rough 8° trunnion and a smooth 8° trunnion
